Review Committee Report on the
Fatal Accident Involving *Imedi*
During the 2018 Chicago Yacht Club Race to Mackinac
on July 21, 2018
Published: February 25, 2019

Committee Members: Christopher Thomas, chair, Nick Berberian, Sally Lindsay
Honey, Jay Kehoe, Matt Knighton, Shawn O’Neill, Sarah Renz, and Ronald White

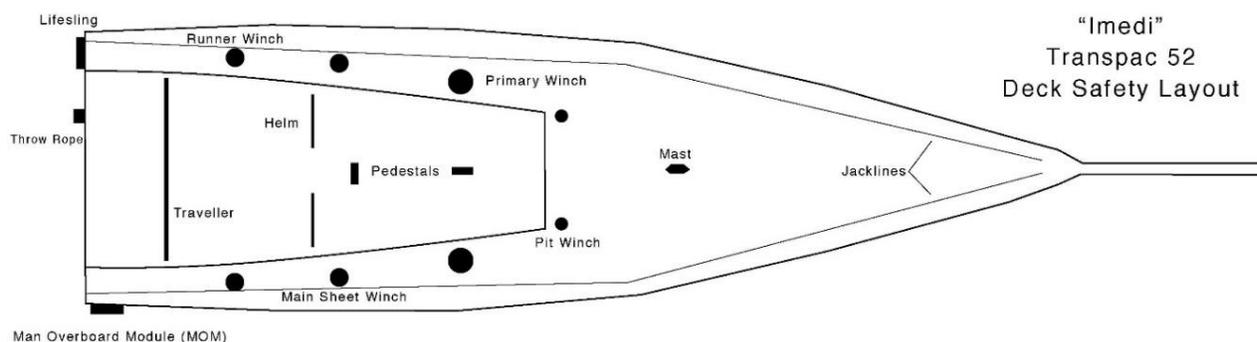
- 3.2. The TP 52 has a large open cockpit, with the vang control located far aft (behind the steering wheels in the center of the deck) and remote from likely handholds and jacklines.

Figure 2: *Imedi* Jacklines- Hydraulic vang controls were on centerline between the wheels

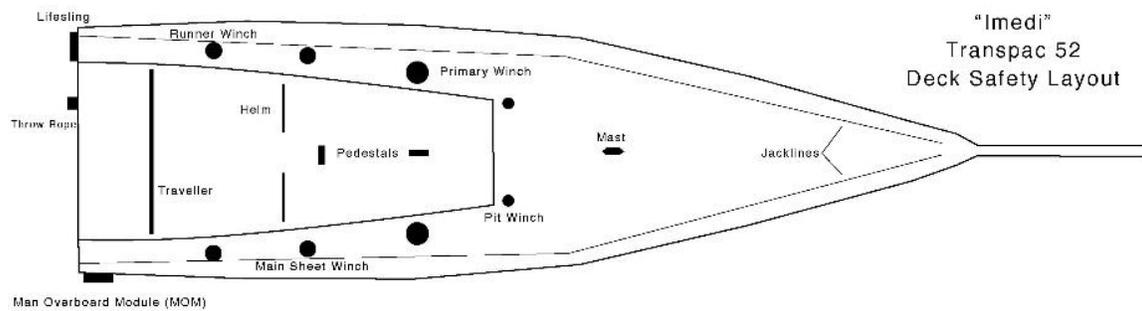
The TP 52 has a large open cockpit, with the vang control located far aft and remote from likely handholds and jacklines.

Figure 5- Imedi Deck Layout: Hydraulic vang controls were on centerline between the wheels

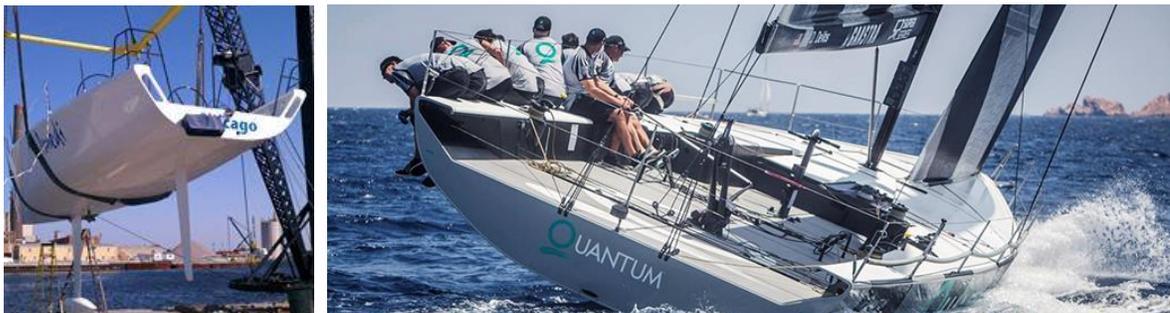
Figure 6 Underwater fins subject to stalling and Open afterdeck with minimal handholds

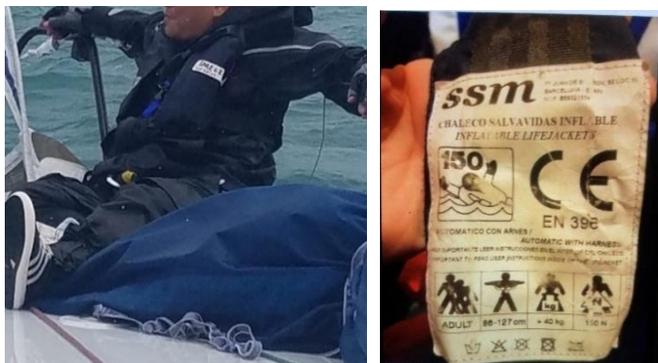
All reports are consistent that Santarelli was wearing an inflatable life jacket at the time he went overboard, and it did not inflate. Nor is there any indication that the manual pull or the oral inflator was attempted to be utilized by him. Had the life jacket inflated, there would have been considerable additional time to effectuate a retrieval of him once he went overboard.

The Hammar MA1 inflator is a hydrostatic type inflator that is utilized in a number of different brands of inflatable life jackets. Based upon interviews with the crew, the life jackets came with the boat, and thus could be as much as 12-13 years old. Whether the inflator mechanism in the jacket Santarelli was wearing had ever been replaced is unknown.

Figure 7 Boat-issued life Jacket and life jacket label

The Safety Alert goes on to make the following recommendations, which the Committee believes need to be reemphasized to the boating public:

The Coast Guard **highly recommends** routine maintenance, service, and inspection in accordance with the manufacturer’s instructions.

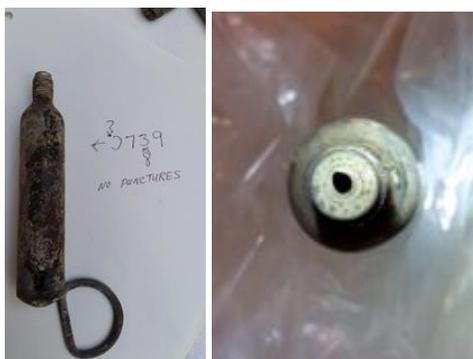
Due to the week-long exposure of Santarelli's body to the water, there was significant decomposition at the time of recovery. Therefore, the Medical Examiner's office, without the knowledge of the Coast Guard, put his personal belongings, including the life jacket, in a bio-hazard bag that was placed alongside the body at the time it was transported for cremation. That is why it was incinerated.

Figure 8 CO₂ Inflation cylinder from Jon's life jacket showing it had not been pierced prior to the incineration

- 2) Require replacement of Co2 cartridges every two years in inflatable pfd's.
- 3) Require all boats to broadcast their AIS position continually. If this event had happened at night or with limited visibility, the consequences could have been far worse
