Review Committee Report on the
Fatal Accident Involving *Imedi*
During the 2018 Chicago Yacht Club Race to Mackinac
on July 21, 2018
Published: February 25, 2019

Committee Members: Christopher Thomas, chair, Nick Berberian, Sally Lindsay
Honey, Jay Kehoe, Matt Knighton, Shawn O’Neill, Sarah Renz, and Ronald White

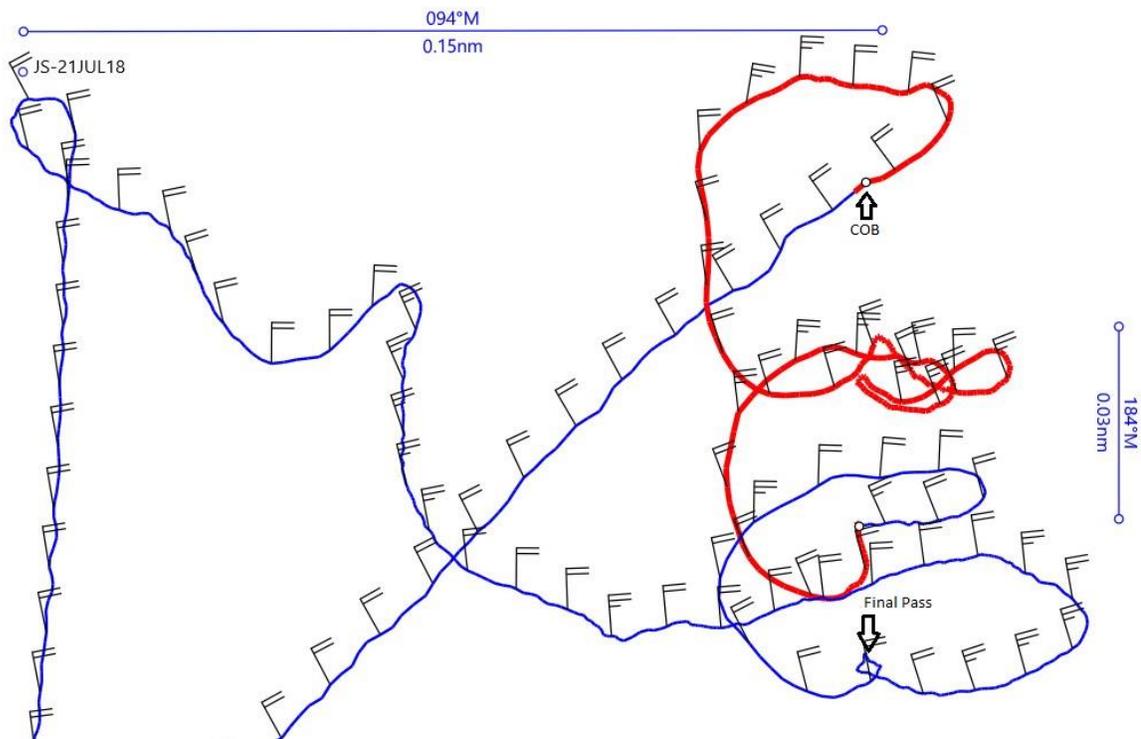
Figure 4: MOB recovery attempt track from approximately 14:24:45 to 14:41:52

6.10.3. In a subsequent interview, the driver demonstrated with props how on all three passes, the boat tacked away onto starboard tack, sailed down below Jon, gybed, and then went head-to-wind with Jon on the starboard side of the boat in an attempt to pass as close as possible to him. Others had conflicting memories of their maneuvers (certain crew reported that Jon was off the port side which may be the result of where and when they observed Jon as the boat maneuvered back to him).

On subsequent review of the large scale image of his Expedition plot (see Figure 4 at 6.4 in The Report narrative), the navigator thought there may have been four passes total, with the first two very close to each other. He thinks it was approximately 4 ½ to 6 minutes from the COB call to the final loss of Jon.

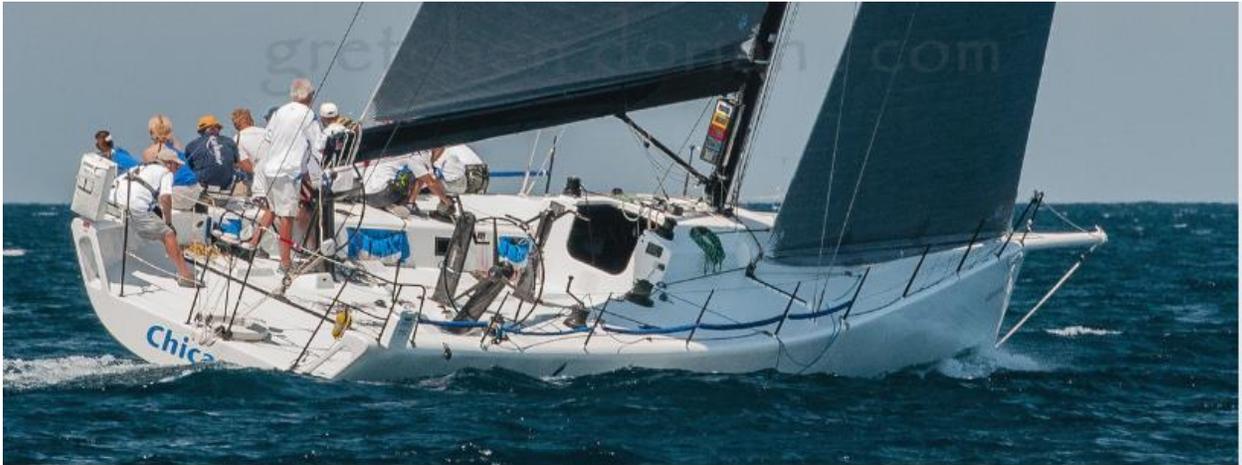
The TP 52 has a large open cockpit, with the vang control located far aft and remote from likely handholds and jacklines.
